Building Handover Report

Buildwise Certification

Handover Building Report.

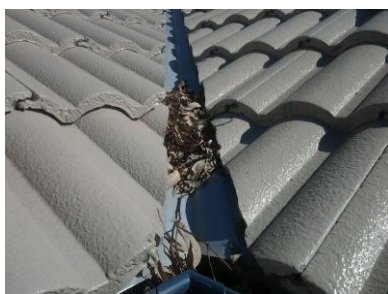
Valleys:

Finished - Remove leaves.

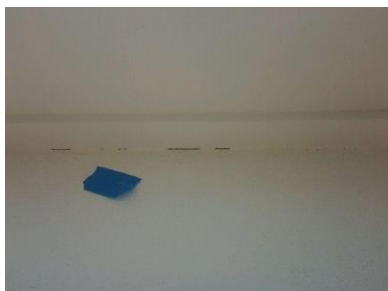
Eave Lining:

Minor paint touch up to timber trim at front right.

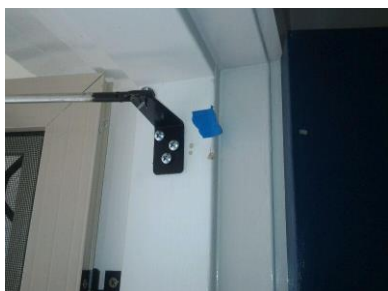
Front Door:

Minor paint touch up required to door jamb.

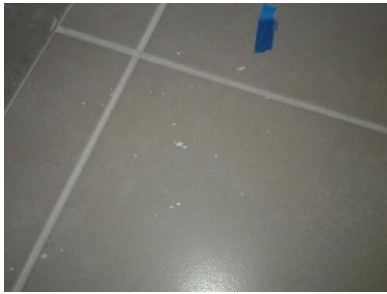
Floor:

Remove excess paint from tiles.

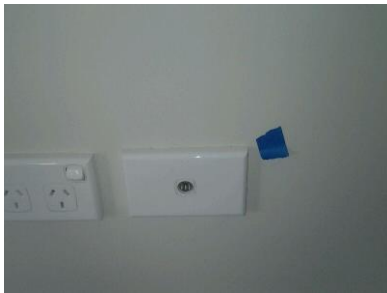
Walls:

Minor paint touch up to TV point.

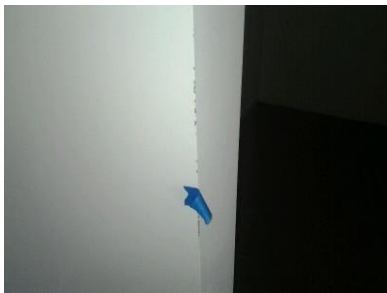
Walls:

Minor paint touch up required.

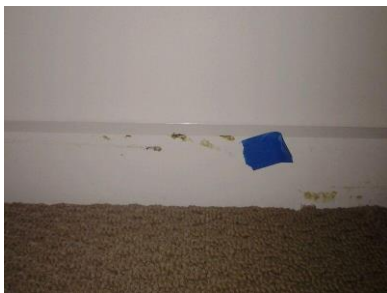
Skirting / Architraves:

Minor paint touch up required.

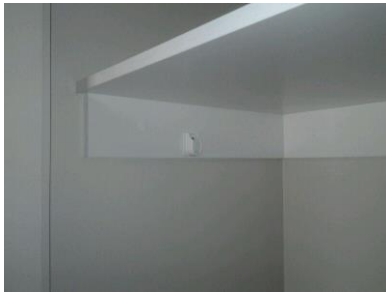
Cupboards / Robes:

Hanging rails not fitted.

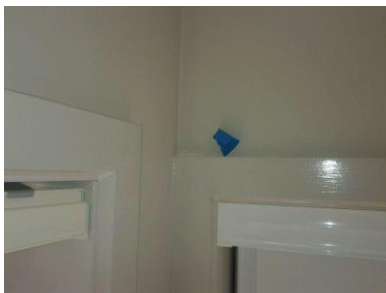
Walls:

Minor paint touch up required.

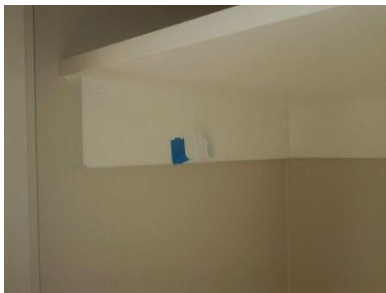
Cupboards / Robes:

Hanging rail not fitted.

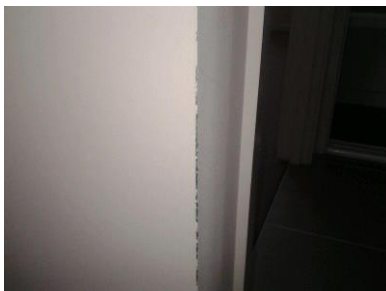
Walls:

Minor paint touch up required.

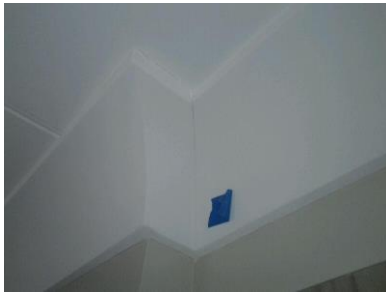
Ceiling / Cornice:

Fill & paint minor cracking to cornice junctions.

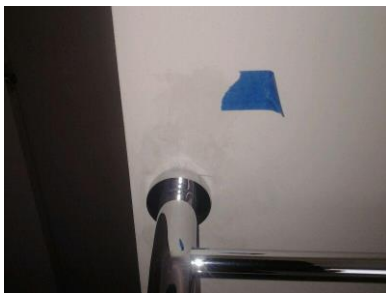
Walls:

Minor paint touch up required.

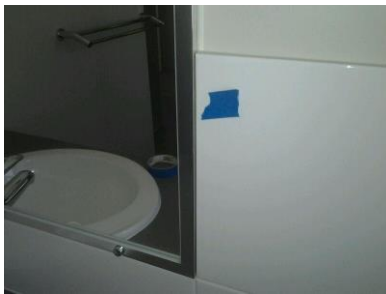
Sealant required to tile edge and mirror.

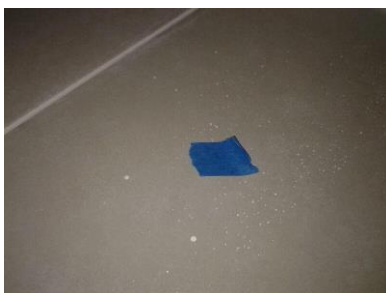
Floor:

Remove excess paint from tiles.

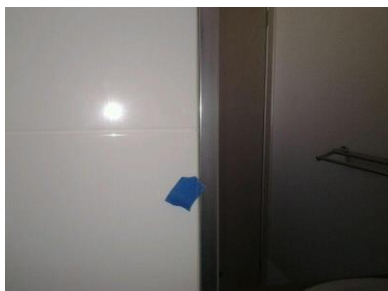
Walls:

Sealant required to tile edge and mirror.

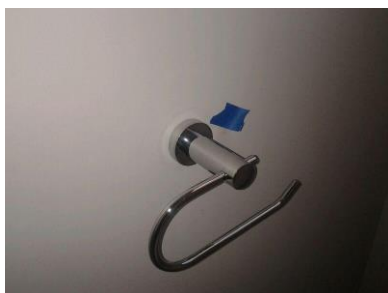
Fittings:

Toilet roll holder is loose and requires re fixing.

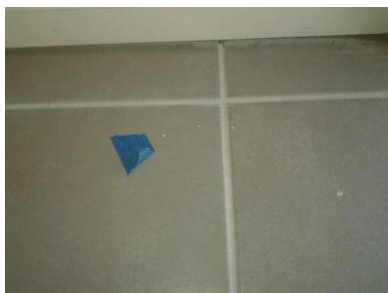
Floor:

Remove excess paint from tiles.

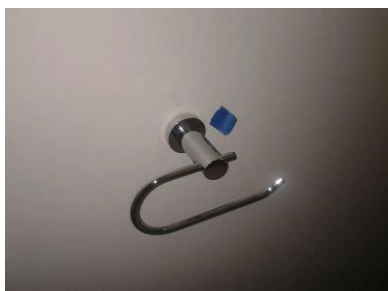
Fittings:

Toilet roll holder is loose and requires re fixing.

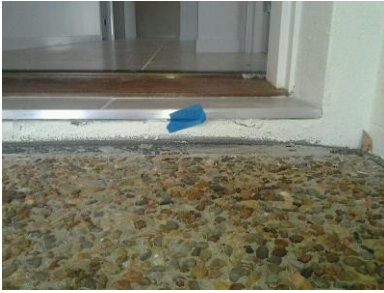
Construction Joints:

Trim expansion joint at front door.

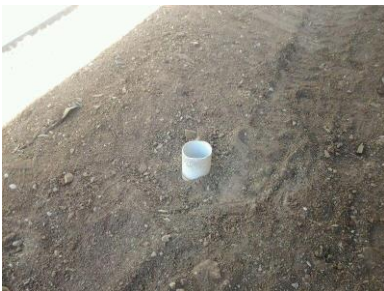
Description:

Yard sinks not yet connected.

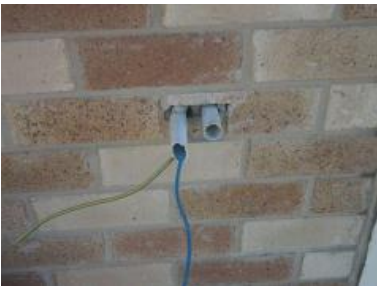
Details:

Telstra yet to fit off externally.

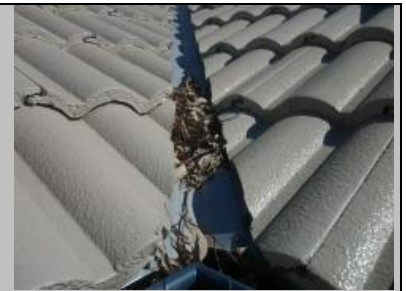
Details:

Finished - Remove leaves.

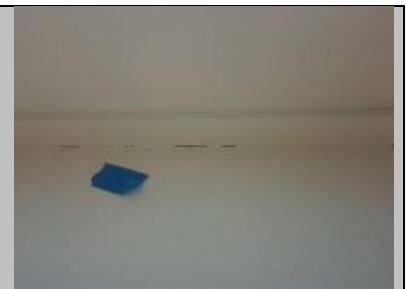
Eave Lining:

Minor paint touch up to timber trim at front right.

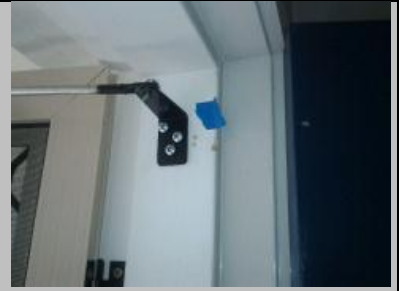
Front Door:

Minor paint touch up required to door jamb.

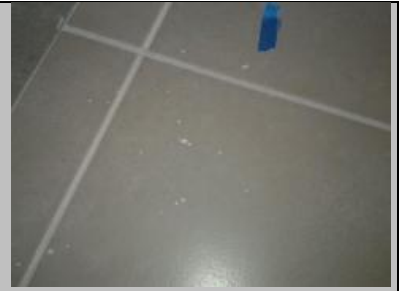
Floor:

Remove excess paint from tiles.

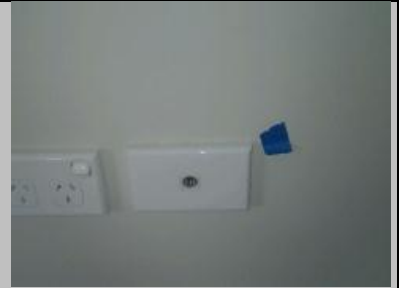
Walls:

Minor paint touch up to TV point.

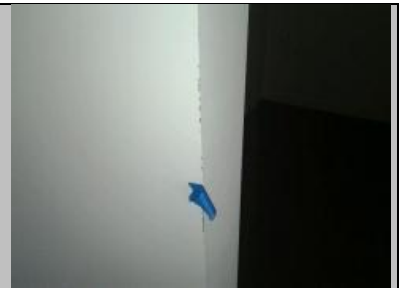
Walls:

Minor paint touch up required.

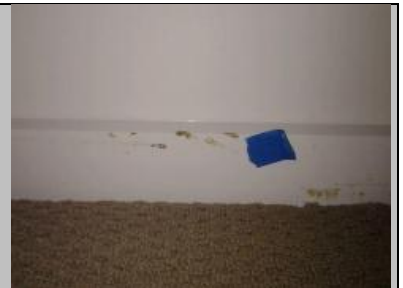
Skirting / Architraves:

Minor paint touch up required.

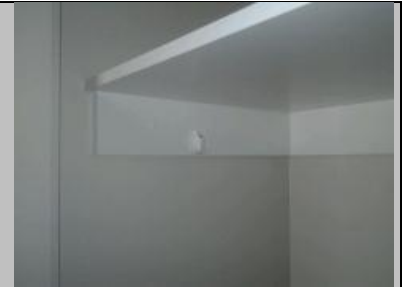
Cupboards / Robes:

Hanging rails not fitted.

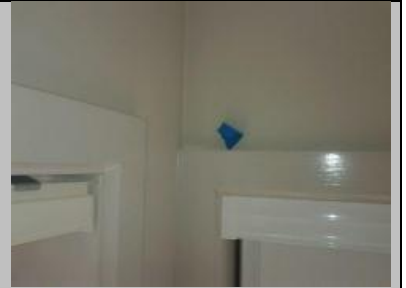
Walls:

Minor paint touch up required.

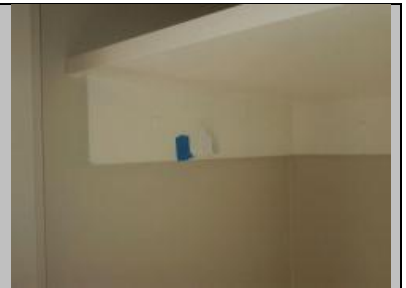
Cupboards / Robes:

Hanging rail not fitted.

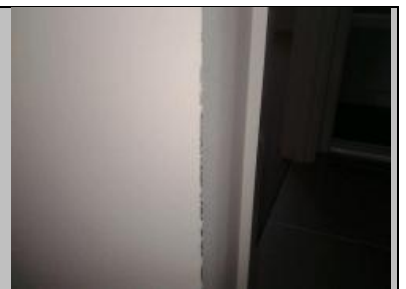
Walls:

Minor paint touch up required.

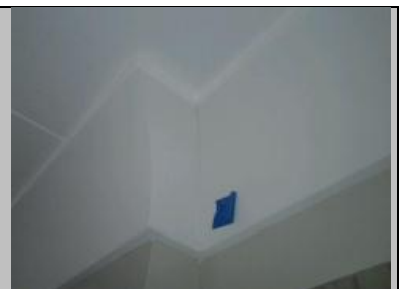
Ceiling / Cornice:

Fill & paint minor cracking to cornice junctions.

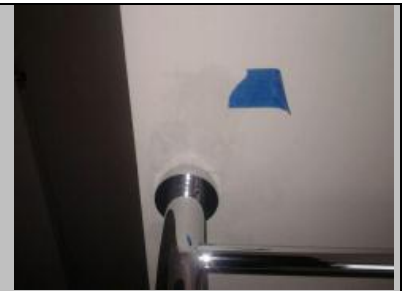
Walls:

Minor paint touch up required.

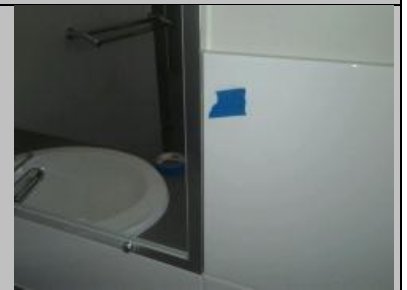
Sealant required to tile edge and mirror.

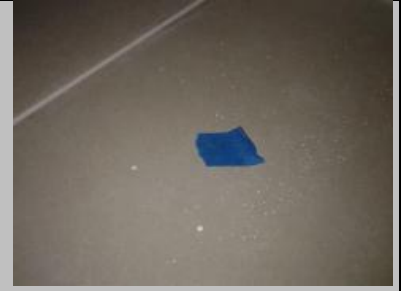
Floor:

Remove excess paint from tiles.

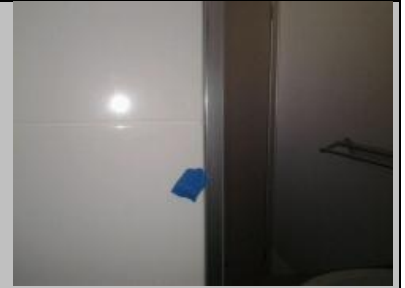
Walls:

Sealant required to tile edge and mirror.

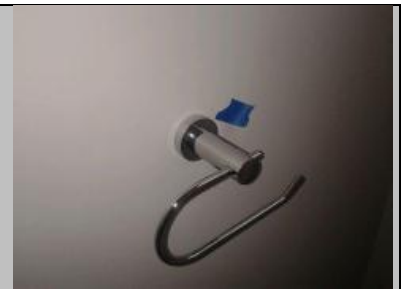
Fittings:

Toilet roll holder is loose and requires re fixing.

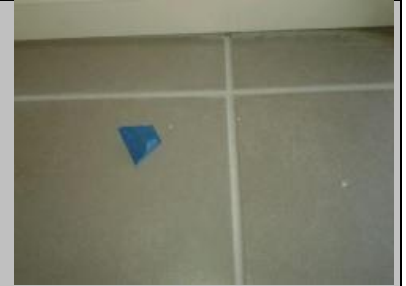
Floor:

Remove excess paint from tiles.

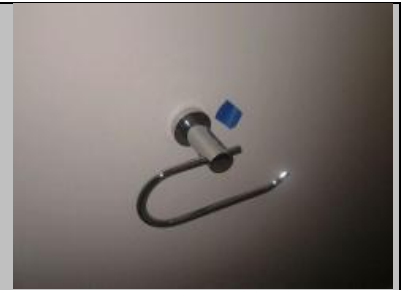
Fittings:

Toilet roll holder is loose and requires re fixing.

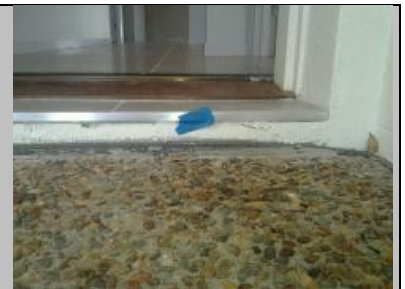
Construction Joints:

Trim expansion joint at front door.

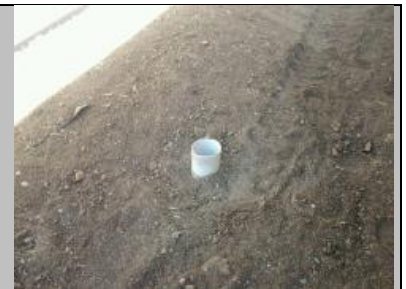
Description:

Site drainage appears to be acceptable.
Yard sinks not yet connected.

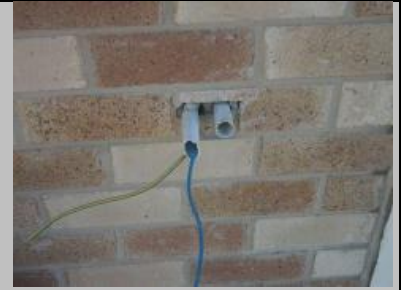
Details:

Telstra yet to fit off externally.
