Building Report

**Purchaser:
Mr & Mrs A. Sample**

**Property Address:
Sample Street
Sample NSW 0000**

**Reference No:
000**

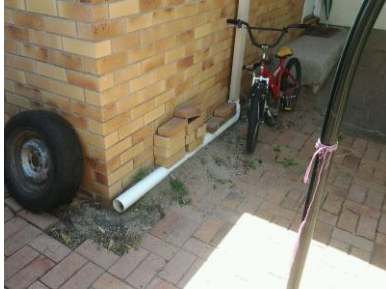
Guttering joints are leaking and should be repaired.

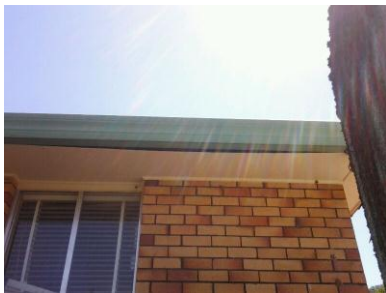
Eaves linings are not fitting into the fascia leaving gaps.

Repairs are required and eaves should be correctly fitted.

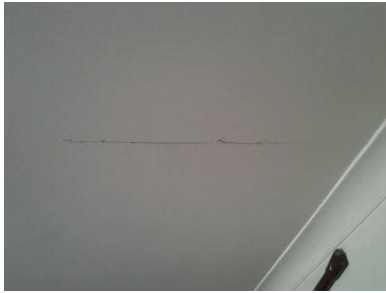
Minor cracking is present to cornices.

This will require maintenance.

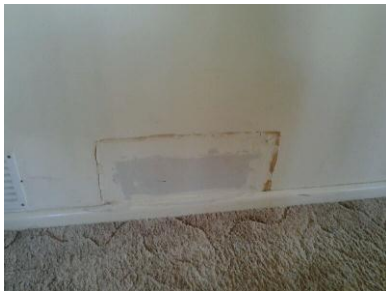
Minor cracking is evident to wall linings.
Periodic maintenance may be required.

Evidence of past repairs adjacent to the shower recess.

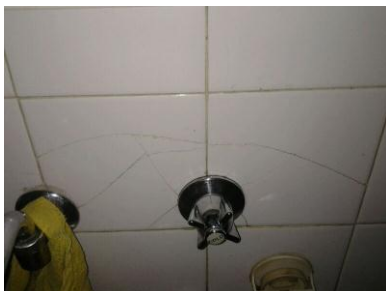
Some cracked tiles were noted in this area.
This is considered a cosmetic issue.
Rectification may be desired and if necessary, contact a floor and
wall tiler for rectification.

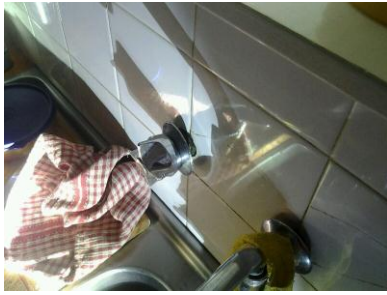
Drain appears serviceable.
Taps require servicing or replacement.

The cabinet appears to be in fair condition for age.

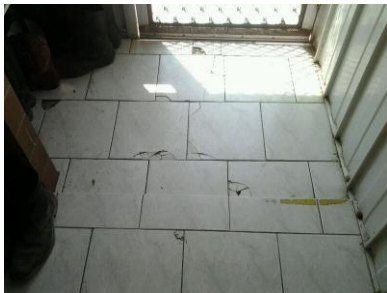
Cracked floor tiles are present and require replacement.

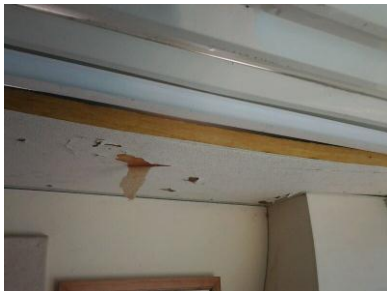
Insulated ceiling panel is loose and requires rectification.

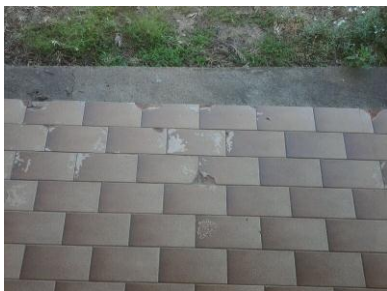
Cracked floor tiles are present and require replacement.

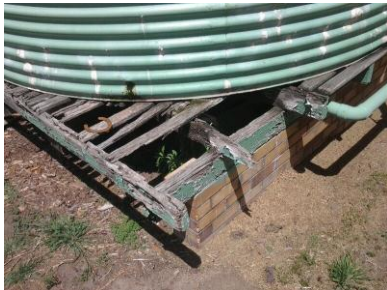
The structure is generally in poor condition.

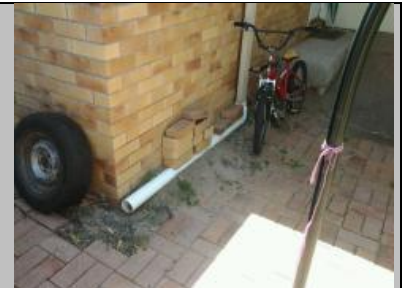
Appear to be in serviceable condition.
Some downpipes do not appear to be connected to a stormwater dispersal system.
This should be rectified.

Leaves and debris are present in gutters.
These should be cleared.
Guttering joints are leaking and should be repaired.

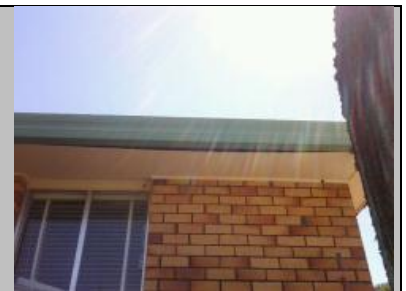
The eaves are lined with fibre cement sheeting.
The overall condition of the eaves lining is fair.
Eaves linings are not fitting into the fascia leaving gaps.
Repairs are required and eaves should be correctly fitted.

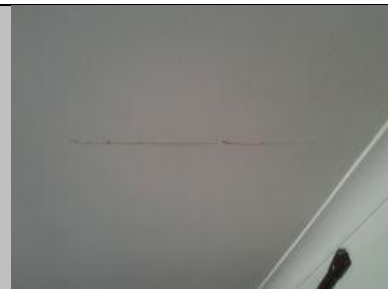
Throughout.

The condition of the ceilings is generally fair. Minor imperfections were noted to the ceiling lining. This is expected in a house of this age. Minor settlement cracks were noted and these are typical of this type of material.

Periodic maintenance may be required. Minor cracking is present to cornices. This will require maintenance.

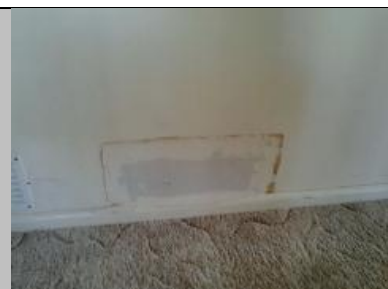
Throughout.

Minor cracking is evident to wall linings. Periodic maintenance may be required.

Evidence of past repairs adjacent to the shower recess.

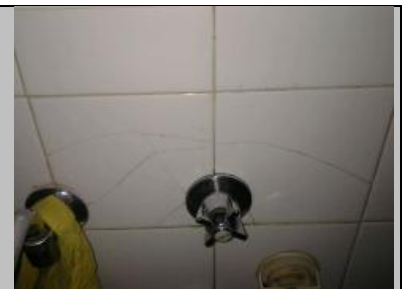
Some cracked tiles were noted in this area.
This is considered a cosmetic issue.
Rectification may be desired and if necessary, contact a floor and wall tiler for rectification.

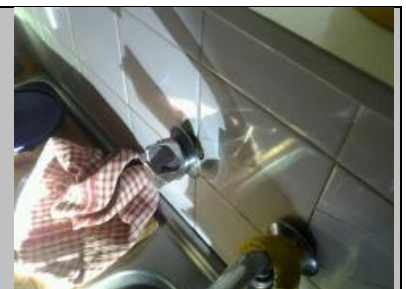
Drain appears serviceable.
Taps require servicing or replacement.
The cabinet appears to be in fair condition for age.

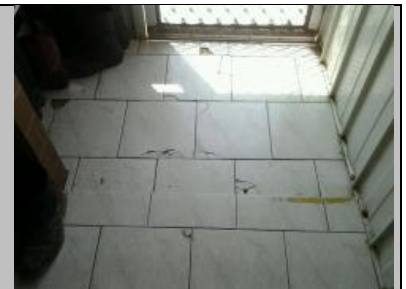
Cracked floor tiles are present and require replacement.

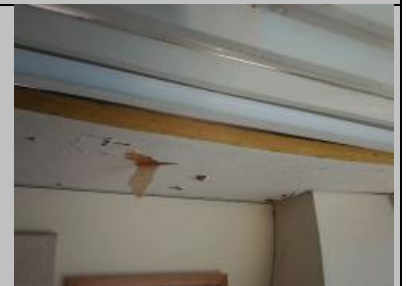
Insulated ceiling panel is loose and requires rectification.

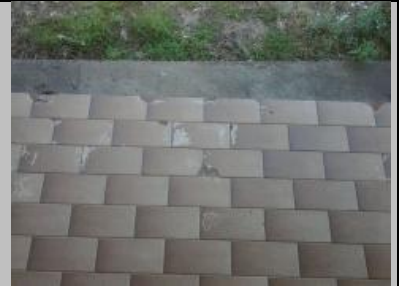
Cracked floor tiles are present and require replacement.

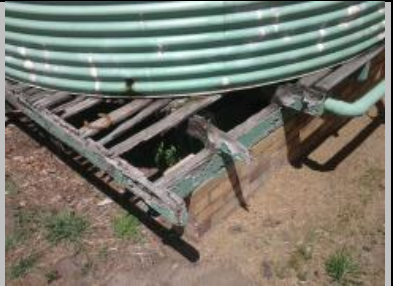
The structure is generally in poor condition.
